Report No. FAA-RD/77/192

# GENERAL AVIATION (FAR 23) COCKPIT STANDARDIZATION ANALYSIS

FINAL REPORT

Prepared for  
**U.S. DEPARTMENT OF TRANSPORTATION**  
**FEDERAL AVIATION ADMINISTRATION**  
**Systems Research & Development Service**  
**Washington, D.C. 20590**

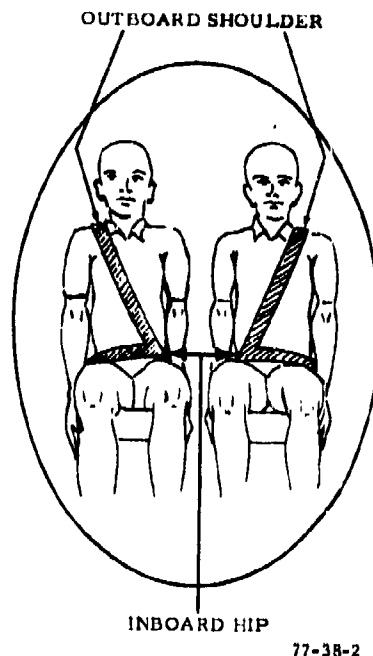
FIGURE 2. UPPER TORSO RESTRAINT INSTALLATION--DIAGONAL BELT

Ideally, the diagonal chest-type restraint anchor point is located on the outboard side of the cabin structure, behind the occupant's outboard shoulder. This anchor point then allows the upper torso restraint to pass over the outboard shoulder and fasten inboard at the occupant's hip as shown in figure 2. This arrangement is recommended to minimize body impact with the side structure of the aircraft cabin in the event of an emergency crash landing.

Aircraft structural design in at least one model precluded this anchor point arrangement because of the location of the doors. In this model, the anchor point for the upper torso restraint was located in the overhead behind and midway between the two front seats. This arrangement brings the upper torso restraint across the chest from the inboard shoulder to the outboard hip; while restricting forward body movement in the event of rapid deceleration, this configuration provides little, if any, protection for body and head impact in forward/sideward decelerations.

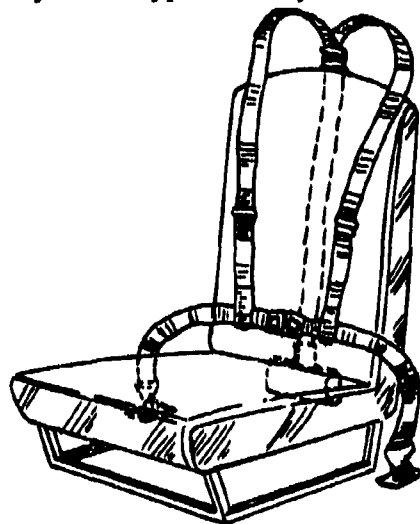
77-38-3  
FIGURE 3. INTEGRAL RESTRAINT WITH DUAL BELTS

In the United Kingdom (UK), the combined efforts of two manufacturers of aircraft products resulted in the development and manufacture of an inertia-reel full harness which consists of two over-shoulder, integral restraints that cannot be unhooked to leave just the lap belts fitted. Both lap and shoulder straps are locked by a single clasp and are adjustable (figure 3).

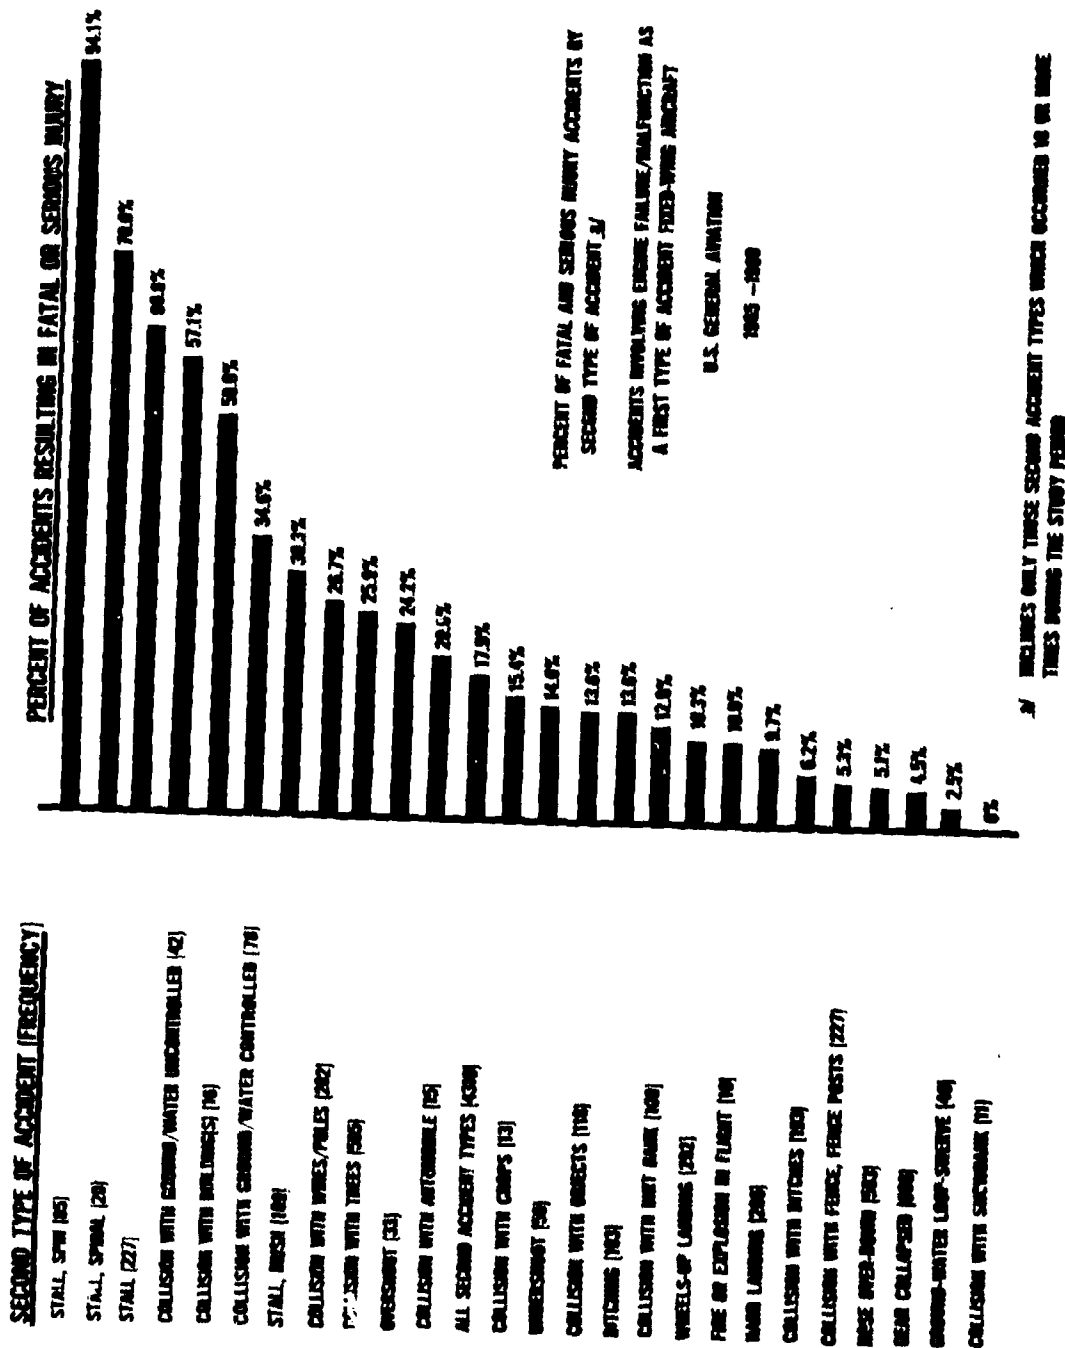
FIGURE 4. FREQUENCY OF SECOND-TYPE ACCIDENTS AS A RESULT OF ENGINE FAILURE

The NTSB accident data for the years 1970 through 1974 (table 1) show 4,954 engine failure accidents. Of this number, 683 (13 percent) were caused by improper operation of the powerplant controls. A summary report of general aviation accidents for the years 1973 and 1974 (reference 34) shows 167 accidents caused by misuse or failure to use carburetor heat, and 43 accidents attributed to misuse of the mixture control. Some examples of mixture control misuse are depicted in table A-6 of appendix A.

A review of NTSB accident data for improper use of powerplant controls (reference 28) indicates that the most common errors were: (1) pilots inadvertently pulling back the mixture control instead of the carburetor heat control, (2) pilots pulling back the mixture control instead of the propeller control, and (3) retarding propeller RPM control instead of the throttle. The first two pilot error actions can result in the complete cut-off of fuel to the engine with subsequent engine failure. The last action results in reduced propeller RPM with ensuing power loss. If the pilot fails to recognize the improper use of the powerplant controls, or does not have sufficient time or altitude to restart the engine, he is faced with a second type of accident situation, the first being engine failure due to powerplant control misuse. (Note: For an engine failure to be classified as an accident, the occurrence must be in combination with another or second-type accident.) The possible consequences of inadvertent, self-induced engine failure resulting in second-type accidents are depicted in figure 4. The data are for all general aviation operations for the years 1965 through 1969, and show the frequency and percent of accidents resulting in fatal or serious injury occurring from a second-type accident. The self-induced engine failure accident is neither isolated nor limited to the inexperienced pilot. The fact that it does occur with a low but regular frequency indicates the need for an amplification of powerplant control design standardization.

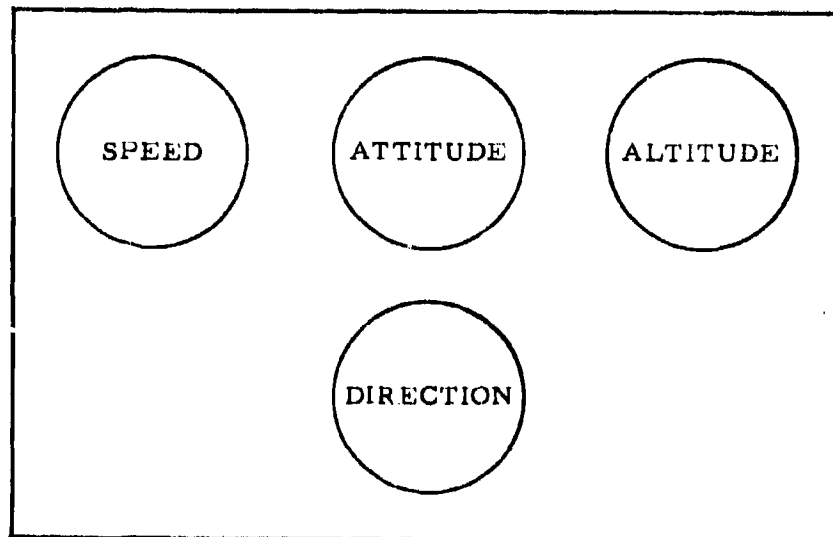
77-38-5

FIGURE 5. BASIC T FLIGHT INSTRUMENT PANEL ARRANGEMENT

Aircraft that have a maximum weight of 6,000 pounds or less are not required to have a standard arrangement of flight instruments on the instrument panel. For FAR 23 aircraft over 6,000 pounds, the four flight instruments which provide basic information on airspeed, attitude, altitude, and direction must be arranged as shown in figure 5 (FAR 23.1321, reference 1).

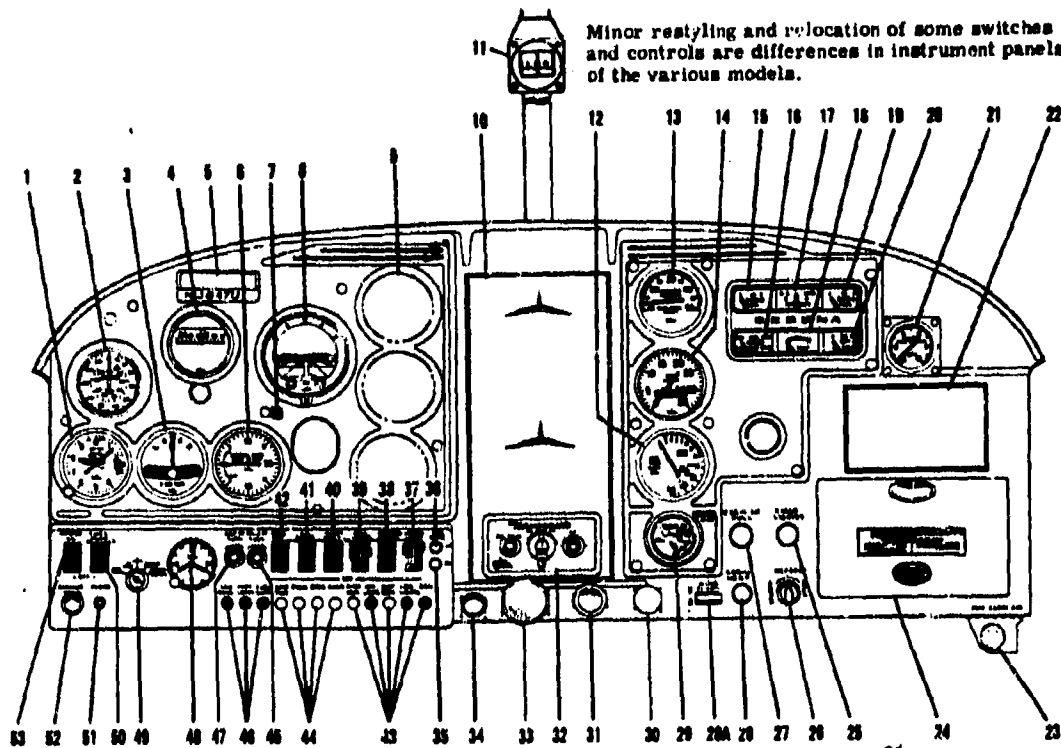
77-38-8

If shockmount has unequal thread length, install shorter threads through stationary panel.

FIGURE 7. SAMPLE OF NONSTANDARDIZED INSTRUMENT PANEL

In 1965, NAFEC instrument flight pilot workload study (reference 36) revealed that the variations in panel arrangements were random and numerous. Examples of the diverse instrument layouts typical of that period are shown in figures 6, 7, and 8.

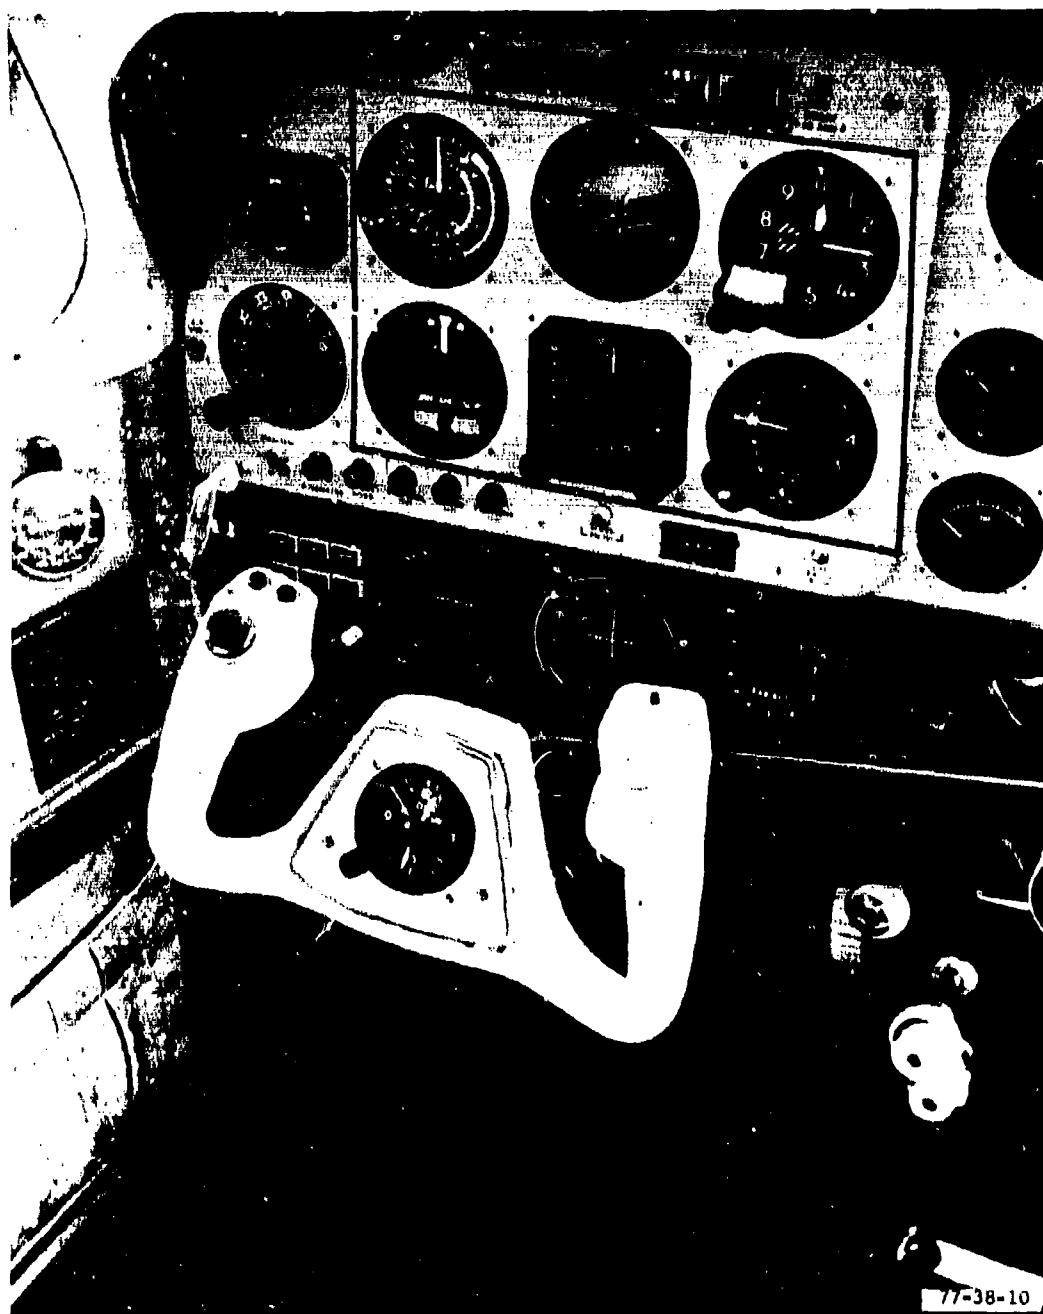
FIGURE 9. EXAMPLE OF A REVISED BASIC SIX INSTRUMENT CONFIGURATION

instruments comprising the T (airspeed, attitude, altitude, and direction), the location of the turn/slip indicator (turn coordinator) and the vertical speed indicator (VSI) has resulted in a "revised" Basic Six arrangement for late model FAR 23 aircraft. The configuration is shown in figure 9.

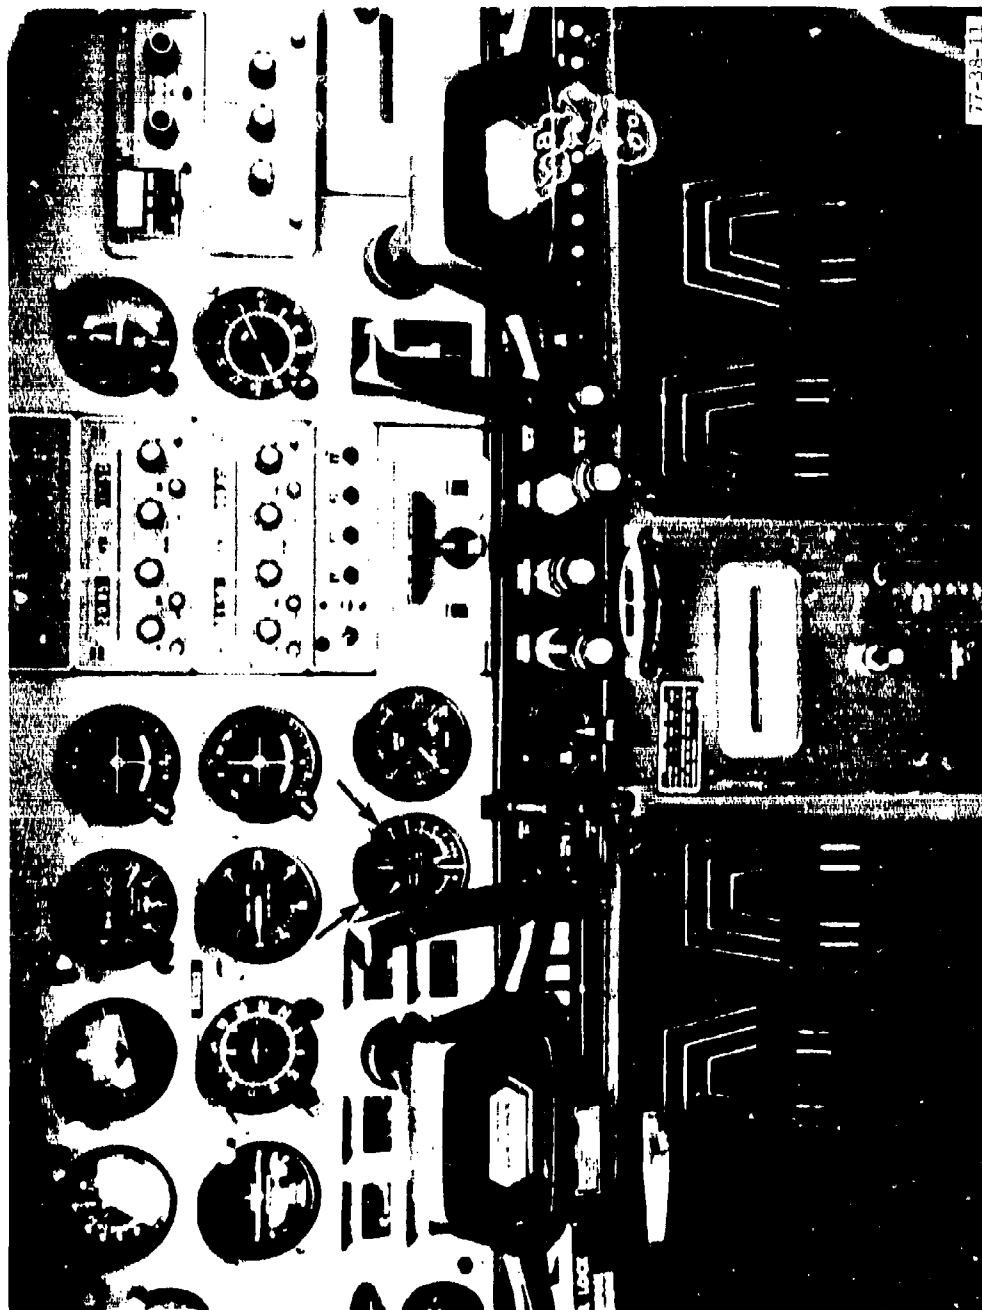
FIGURE 10. COMBINATION OF POWER PLAN INSTRUMENTS

panel does not allow for a desirable grouping or sequenced arrangement. A typical single-engine example is shown in figure 10. The manufacturer at times must position the powerplant instruments in a vertical line on the panel while the standard arrangement of the powerplant controls is a horizontal arrangement, either on the panel or on the powerplant control quadrant. Ideally, the manifold pressure gauge should be located on the panel in line with and above the throttle, the tachometer in line with and above the propeller control, and the fuel flow indicator in line with and above the mixture control. This arrangement is not always possible when, for example, the indications for manifold pressure and fuel flow are incorporated in one instrument (figure 10).

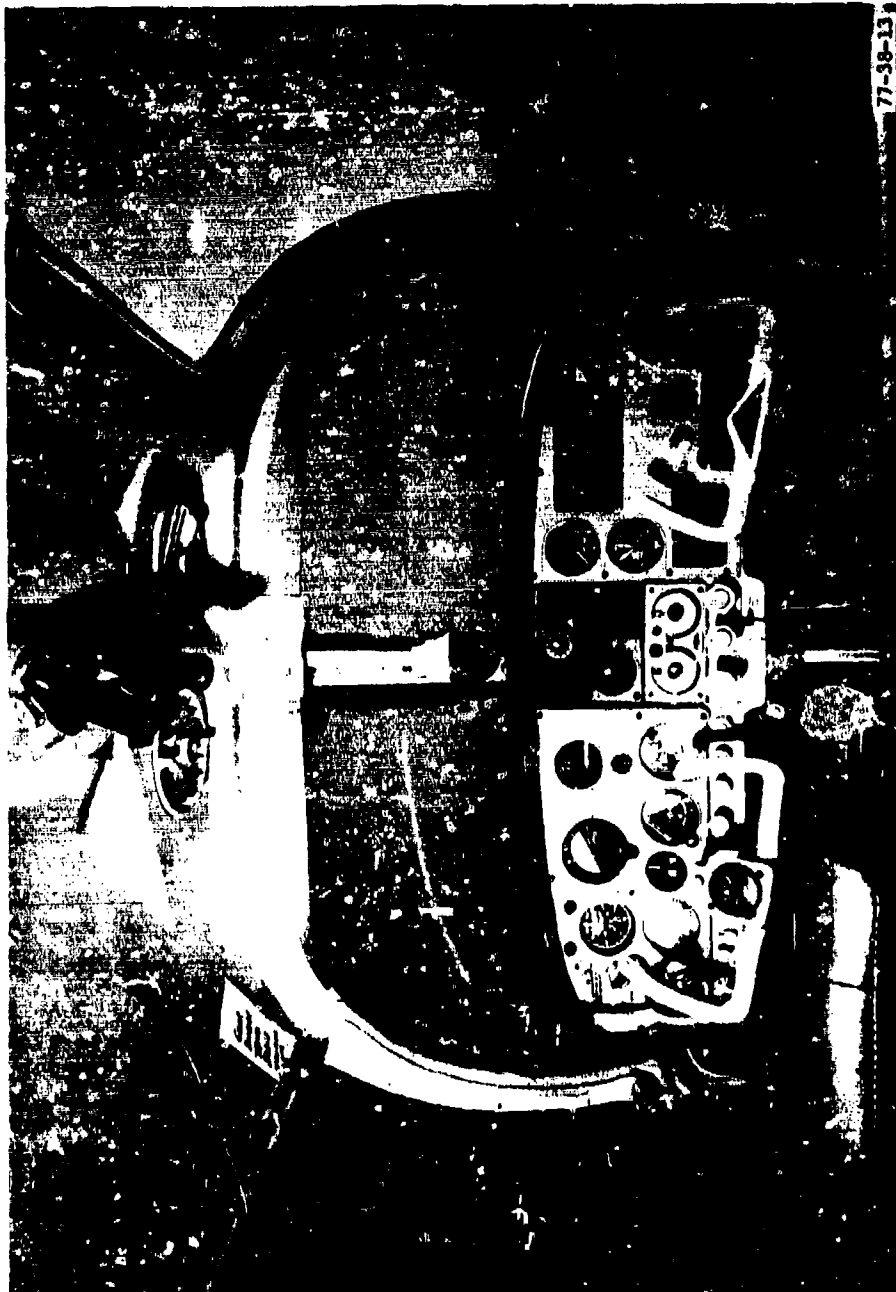
FIGURE 12. OVERHEAD CABIN FLOODLIGHTING SYSTEM

While it may be reasonable to permit the use of floodlighting as a means of meeting these panel and control lighting requirements, it is unreasonable to allow a single light for this purpose. Not only is there a risk of lamp failure when using one light, but the problem of light blocked by the pilot's body, a handheld chart, or other material is critical. Workload is increased when the pilot must put down the chart to see the panel or has difficulty reading the instruments on the panel. Hence, a minimum acceptable floodlight system would be two lights, pointing from different angles so that one would continue to light areas in which light was blocked from the other. A system of this sort is illustrated in figure 12, but it should be noted that the lights are too close to each other. Relocation of one light to the side might provide better light distribution, but would require judgment of each case on its own merits. The best action to take for improved and standardized night lighting would be to amend present FAR 23.1381 which now states that a cabin dome light is not an instrument light. This exclusion of a cabin dome light as an instrument light could be expanded to exclude a single floodlight as an acceptable instrument light.

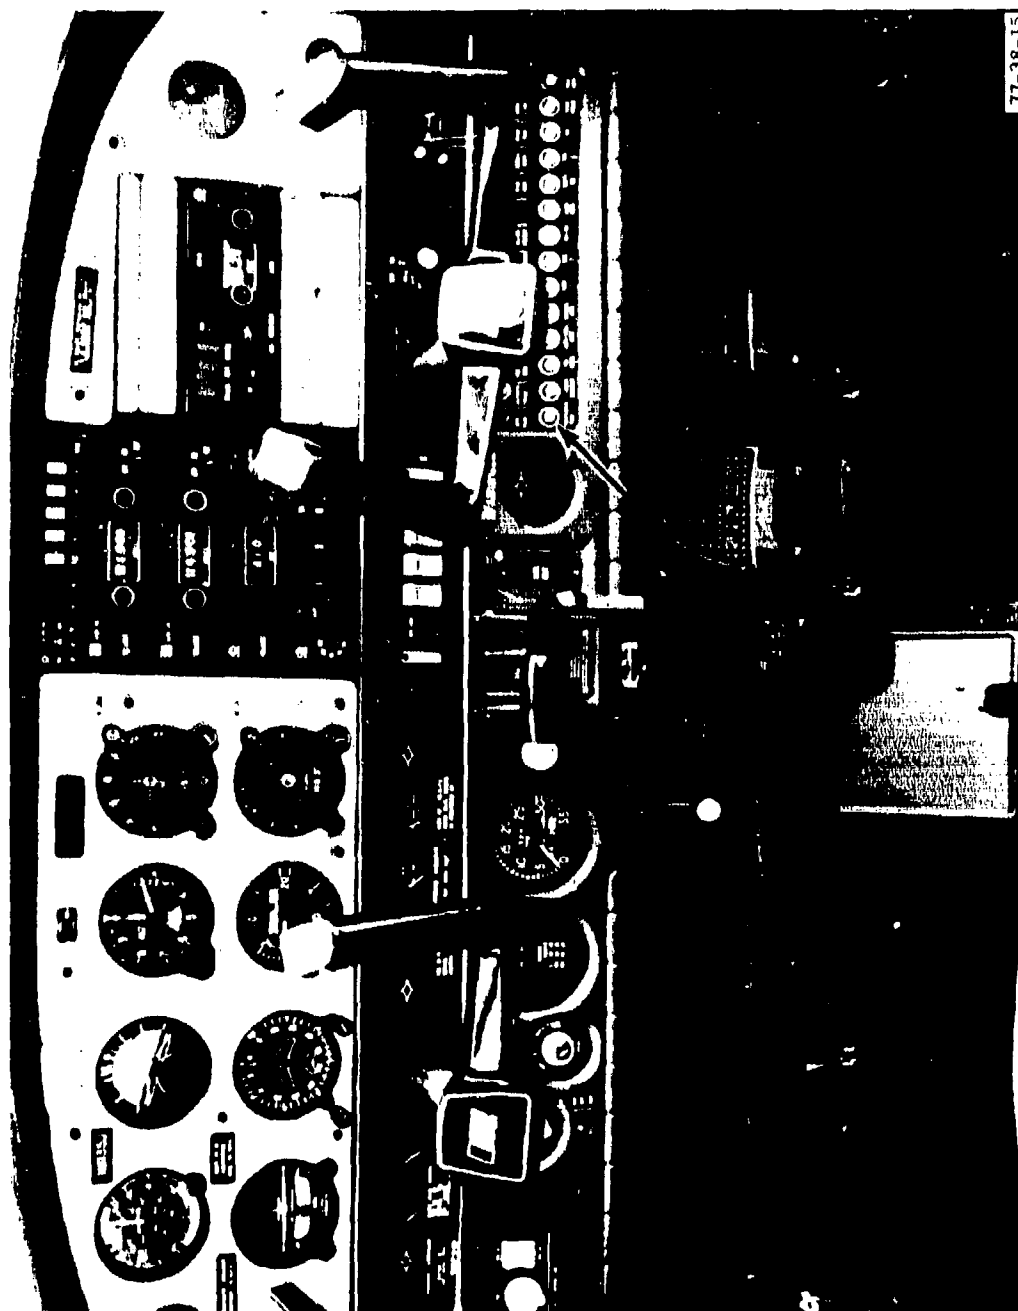
FIGURE 14. TYPICAL CIRCUIT BREAKER LOCATION IN A SINGLE ENGINE AIRCRAFT

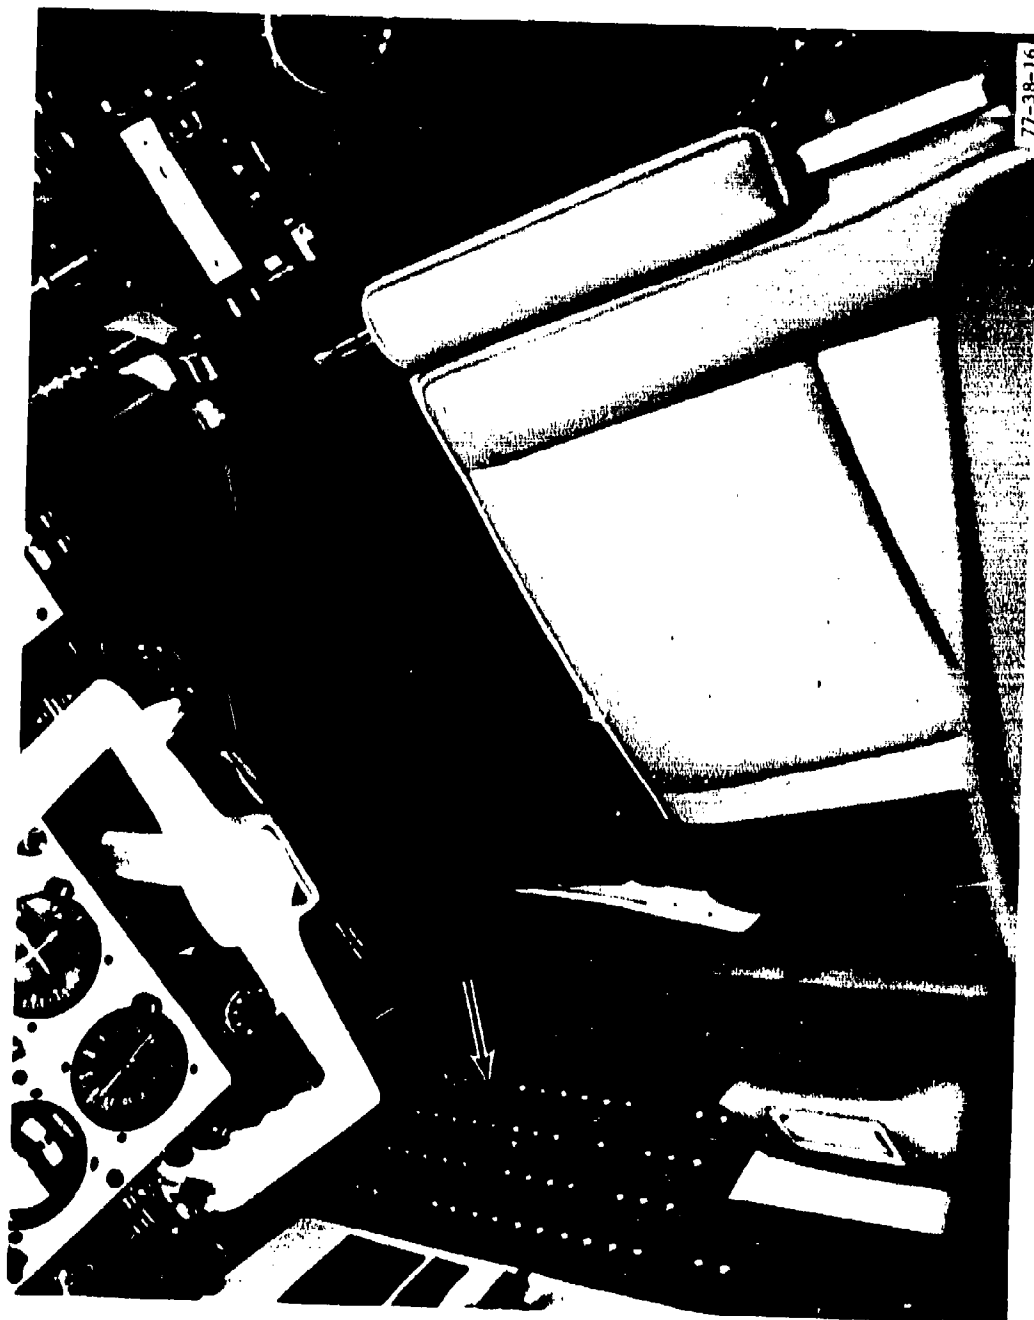
FIGURE 15. CIRCUIT BREAKER PANEL—MULTIENGINE AIRCRAFT

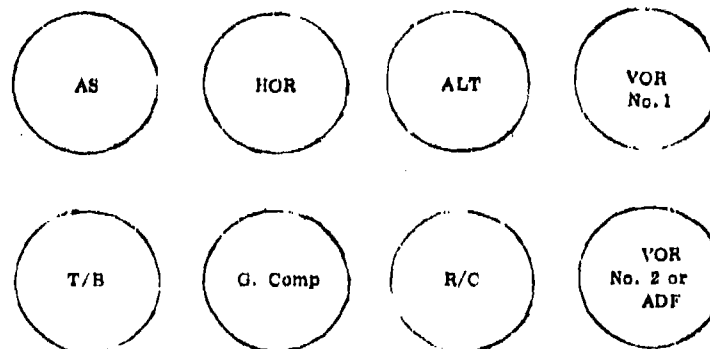
FIGURE 1

AS	Airspeed Indicator
HOR	Gyro Horizon Indicator
ALT	Pressure Altimeter
T/B	Turn and Bank (Slip) Indicator
G. Comp.	Gyro Compass
R/C	Rate of Climb Indicator
VOR	Course Deviation Indicator and Omni Bearing Selector

- 4.1 Figure 1 shows the general relationship of the flight and navigation indicators for one pilot aircraft or the Captain's position when two pilot position instrument panels are used.
- 4.2 When two instrument panels are used for two pilot aircraft the flight instruments for the copilot should use the same arrangement as the Captain's except that the VOR No. 1 and VOR No. 2 may be disregarded.
- 4.3 The No. 2 VOR position is the preferred position for the second VOR indicator. If only one VOR is used or if another navigation instrument is used nearly equally with the VOR, that indicator may be placed in the No. 2 VOR position.
- 4.4 An Instrument Landing System glide slope cross pointer, when used, should be incorporated into the VOR No. 1 position.

- 5.1 The gyro horizon or instrument that most effectively indicates attitude should be as near as possible to the top most position and as near as possible to the center of the pilot's position.
- 5.2 Other indicators should be located in the general position shown in Figure 1. It is not intended that they be placed in rigid horizontal and vertical lines (although it is preferred). The indicators should be in uniformly spaced groupings in front of the pilot position.

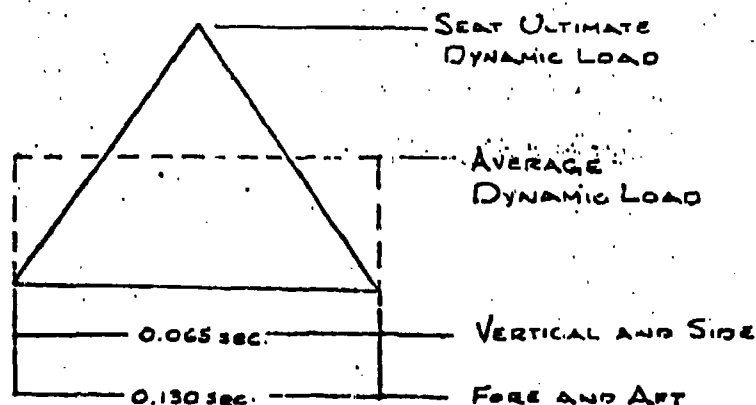
FIGURE 2  
DYNAMIC LOAD PULSE SHAPE

- 4.4.2.1 A forward load of twenty-five (25) g's applied twenty (20) degrees to either side of the longitudinal axis, an aft load of 5 g's, an upward load of 15 g's and a downward load of 15 g's. Load directions should be determined with respect to the longitudinal axis of the airplane. The pulse shapes and durations for the above loads are specified in Figure 2. Load factors should be measured at the seat tracks or on the corresponding air-frame support structure.

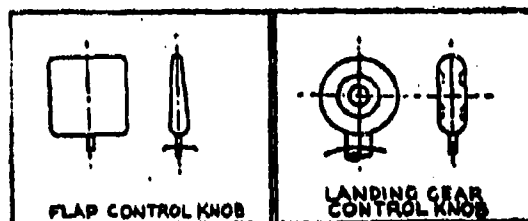
Cockpit control knobs must conform to the general shapes and color (but not necessarily to the exact sizes or specific proportions) as shown in the following figures:

QUADRANT MTD		PANEL MTD		BASIC COLOR
				BLACK
THROTTLE CONTROL KNOB				
				BLUE
RPM CONTROL KNOB				
				RED
MIXTURE CONTROL KNOB				
				GREY
CARB HEAT OR ALT AIR CONTROL KNOB				
				BLACK
SUPERCHARGER CONTROL KNOB
